Pelican Bay Leisure Pool
Structural Evaluations
Edmond, Oklahoma
April 24, 2023

City of Edmond – Pelican Bay

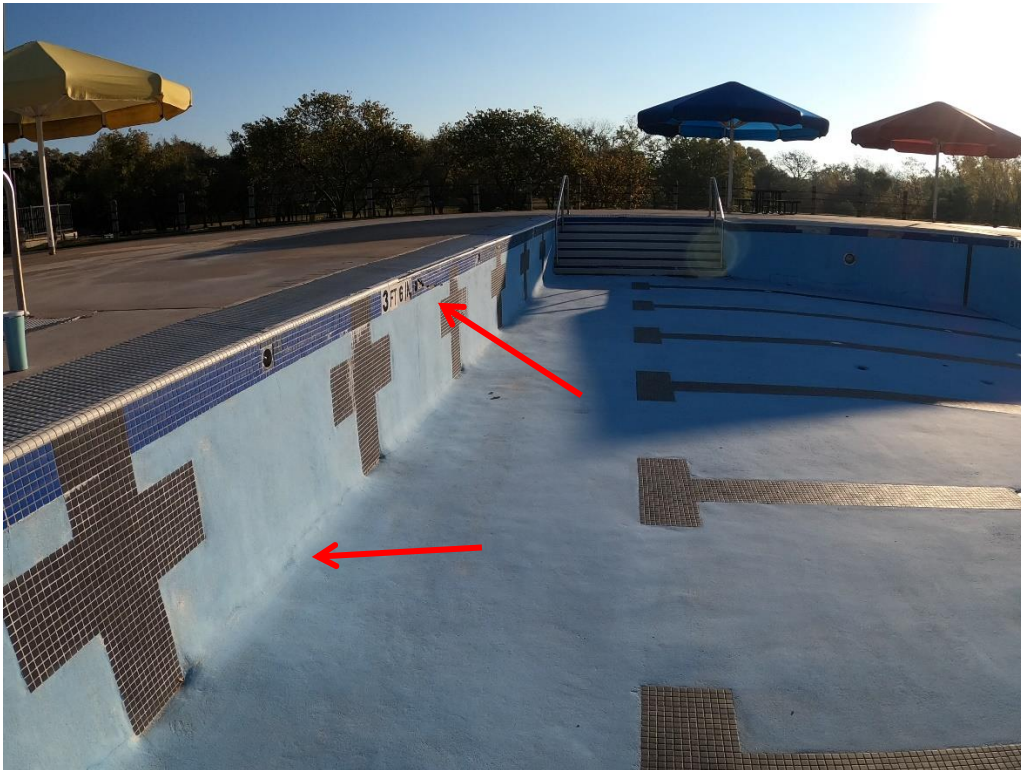
North of lap area. Cracking on base of wall and tile spalling.

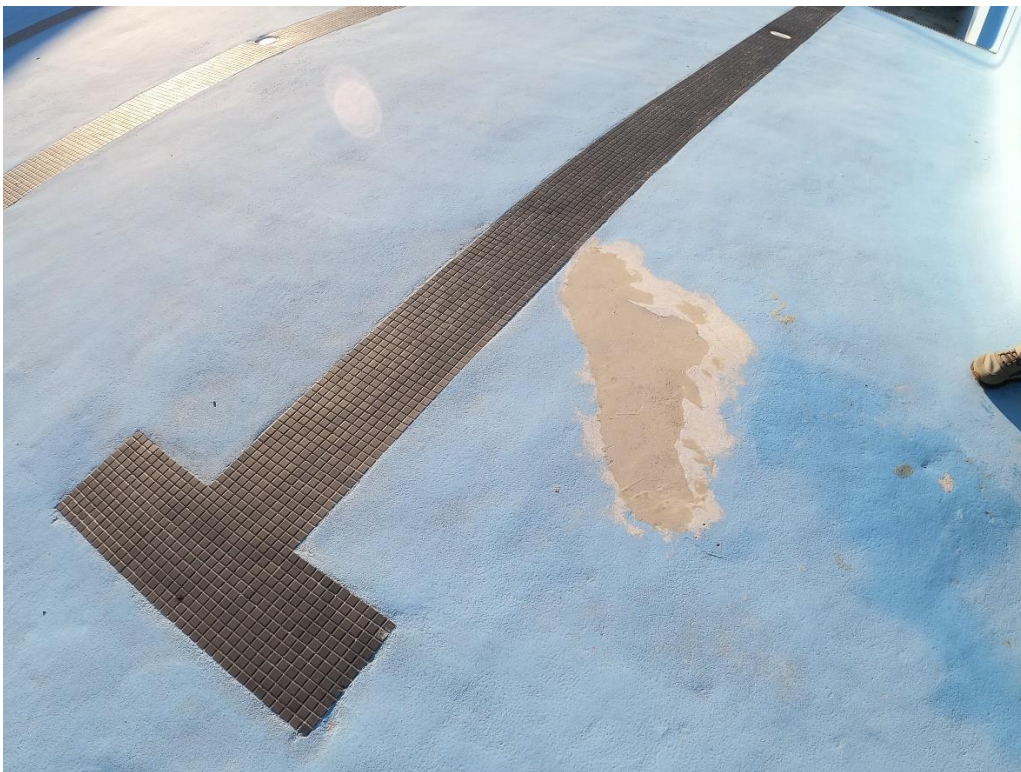
Floor patch in lap area where paint and subsurface finish has peeled off.

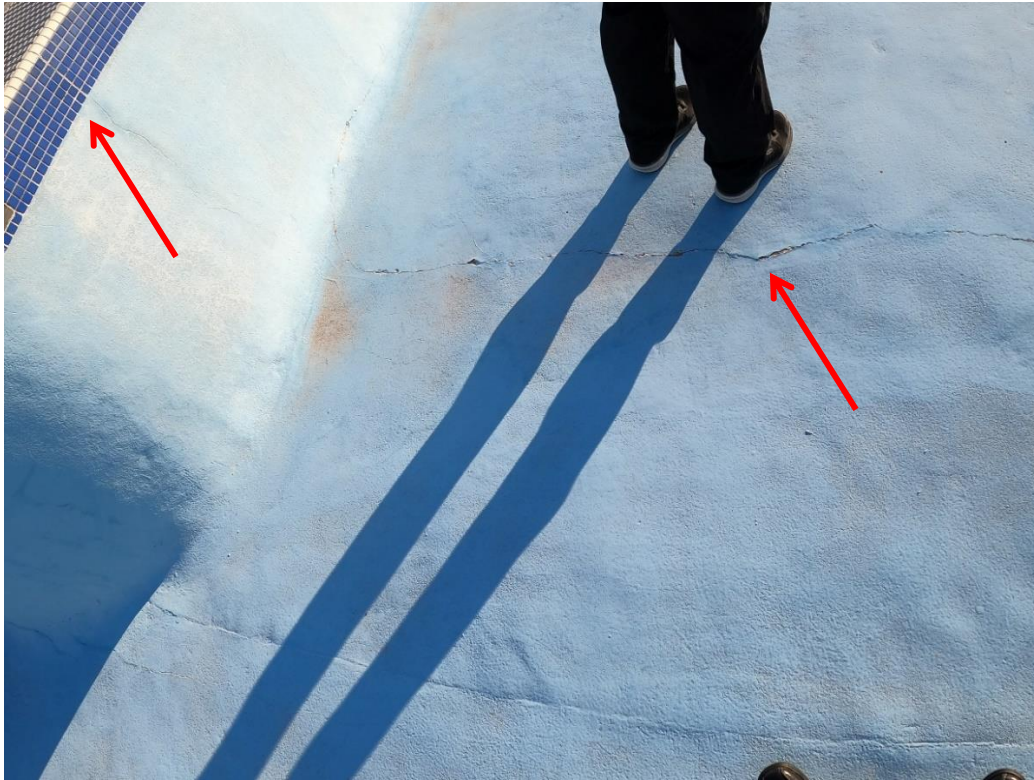
Cracks at shallow lap area extending from wall to floor.

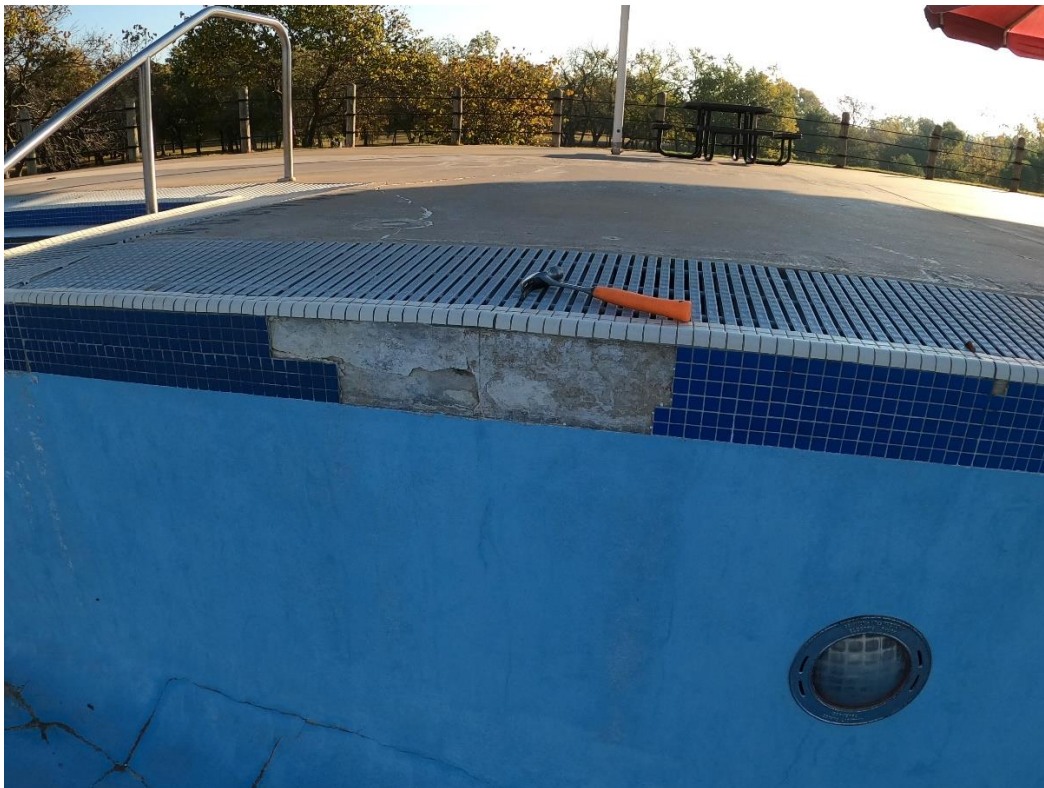
Spalling tile at gutter. Appears to have waterproofing material under the tile.

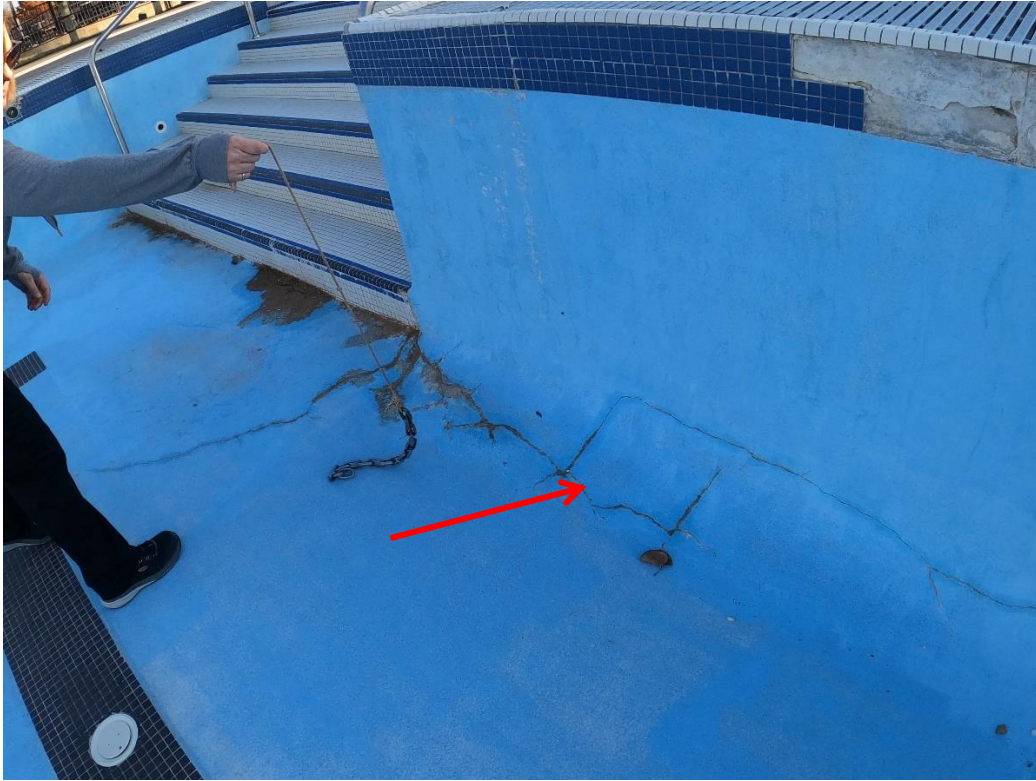
Movement at the stairs evident by cracking extending toward the deep end.

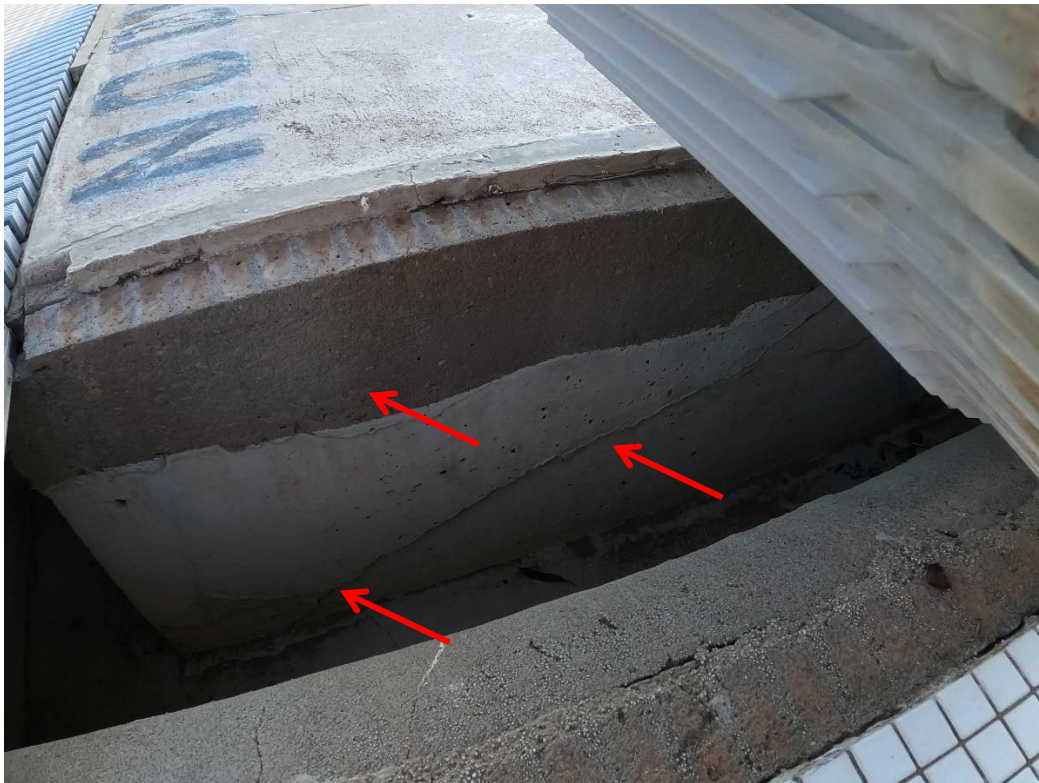
Waterproofing coating does not extend high enough on the backside of gutter. There is also cracking on the backside of the gutter.

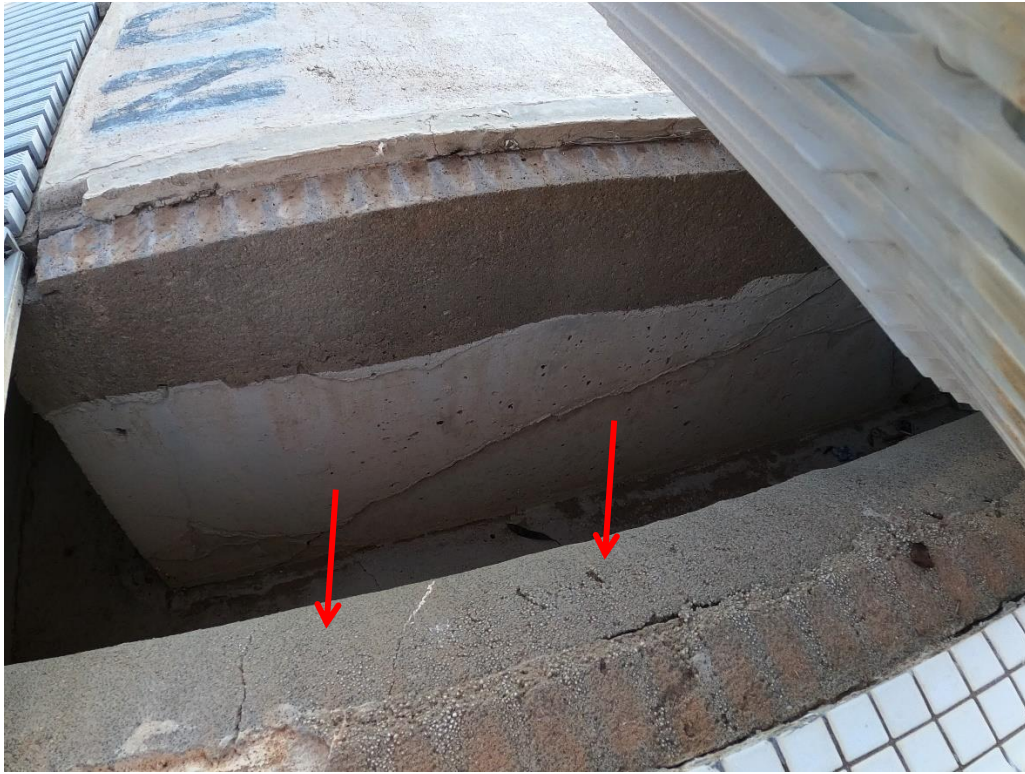
The setting or buildup forming the front gutter wall appears to be too grainy of a grout and is not coated with waterproofing on the interior.

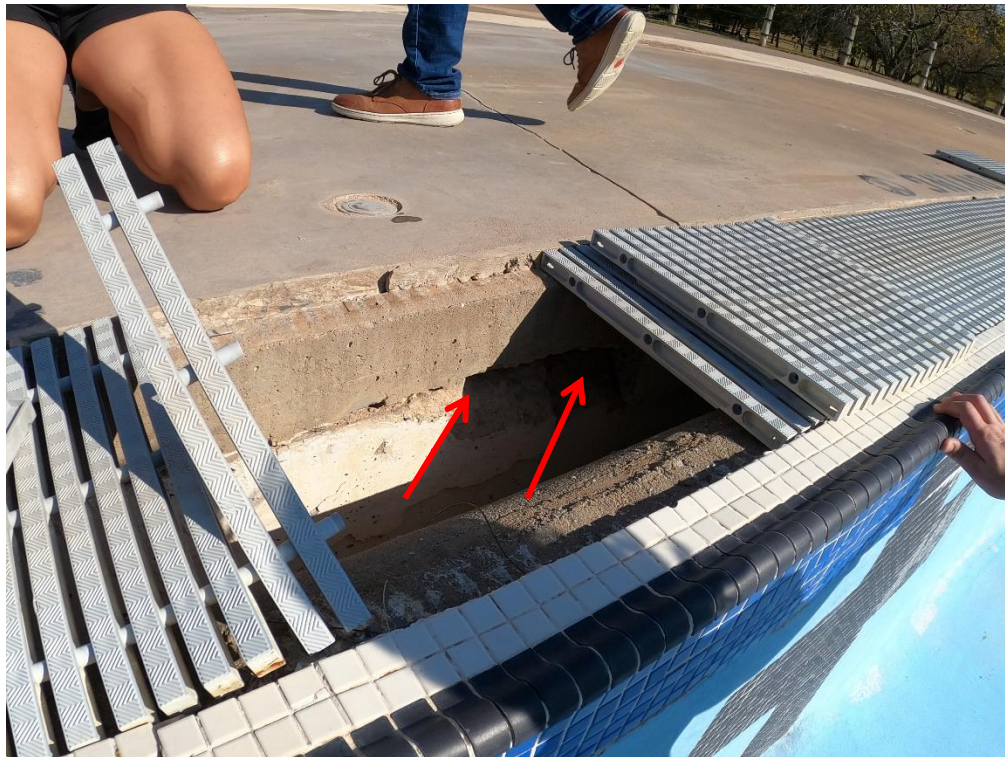
There is a large horizontal crack in the back wall of the gutter on the north end of the lap area.

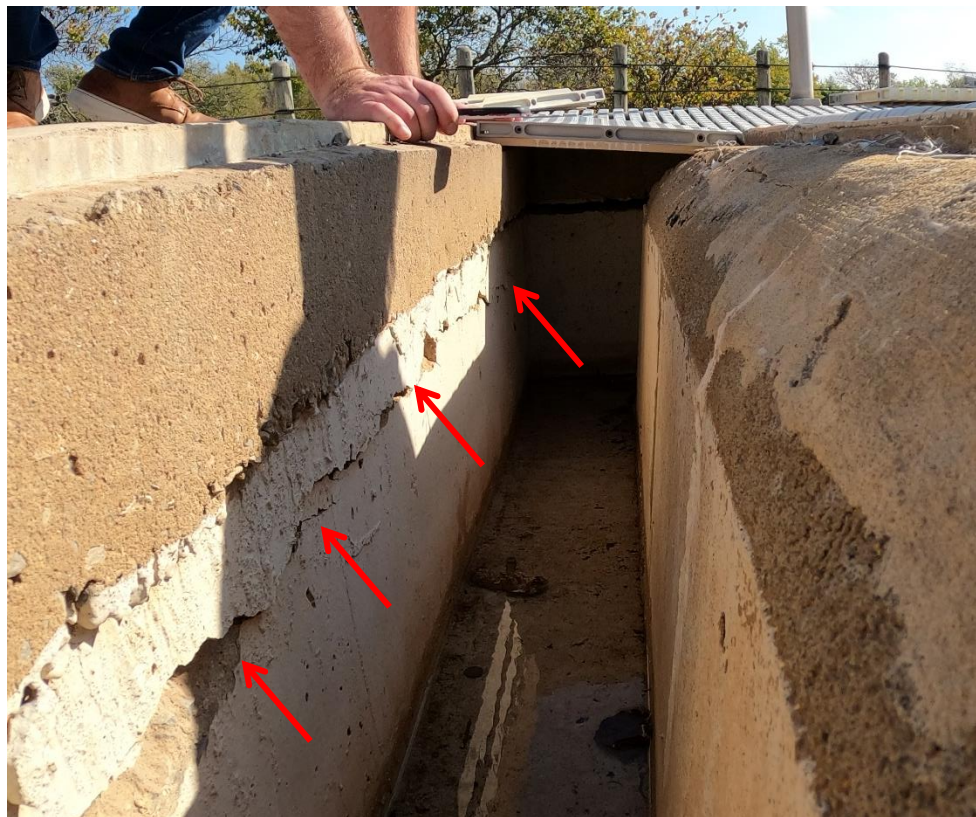
The crack begins roughly mid-length of wall and extends toward the stair in the lap area.

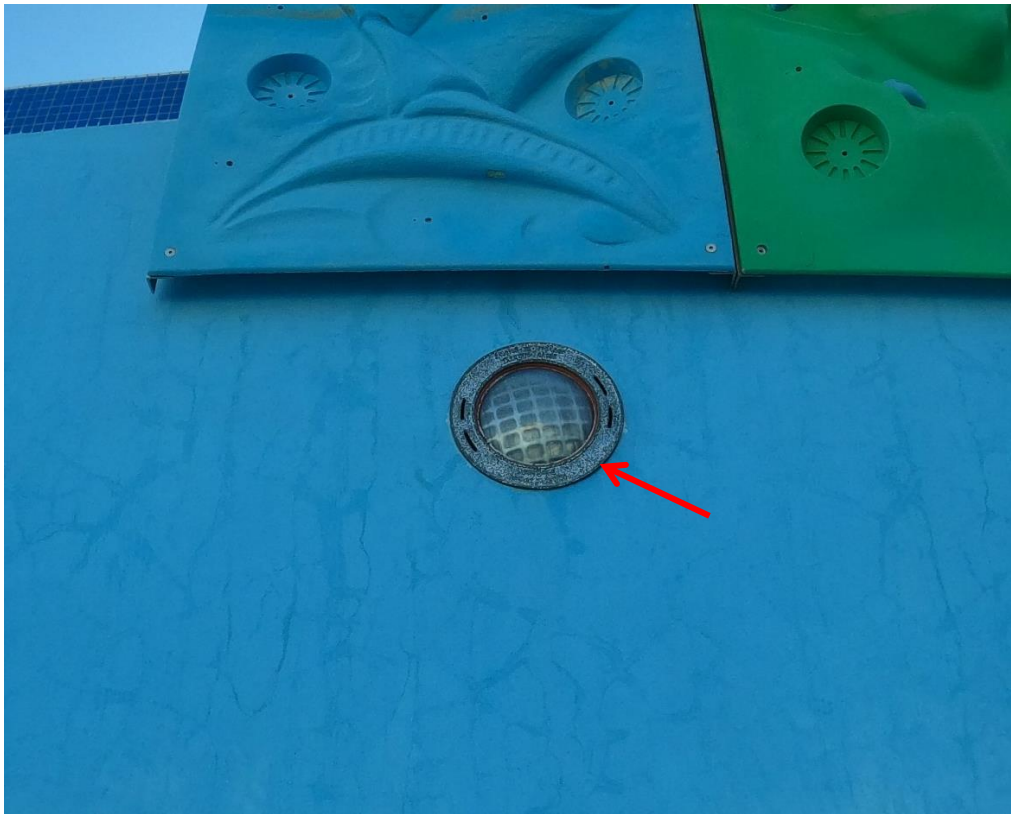
The light rings look to be corroding. It may be that the niche is not bonded.

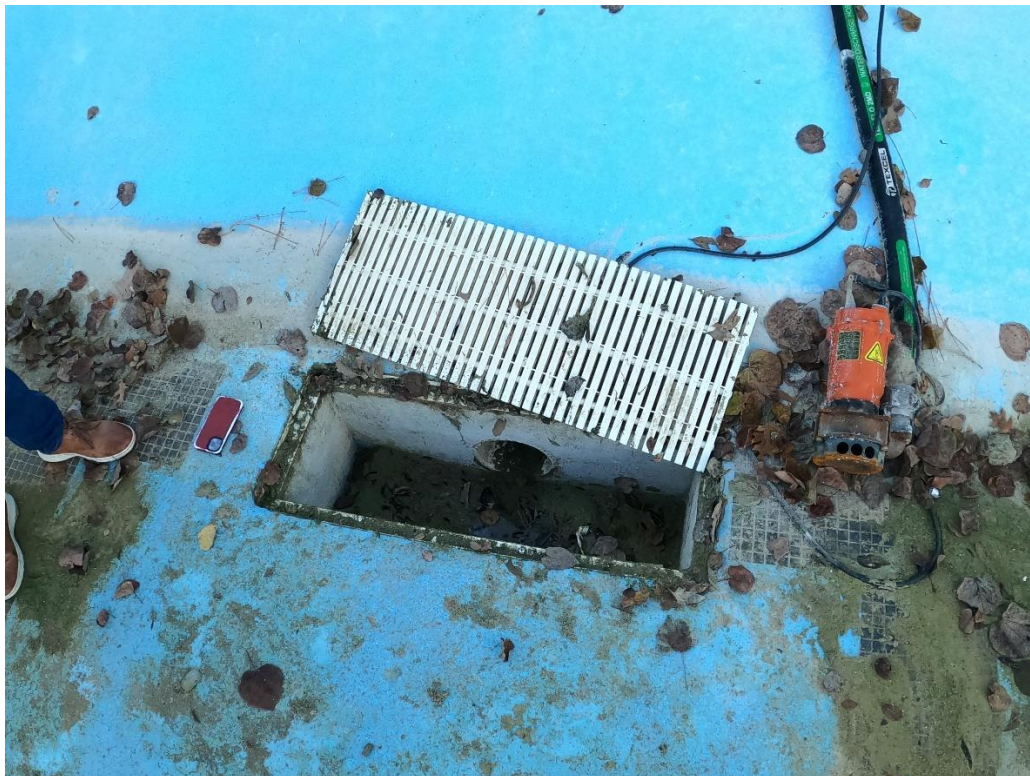
Drains are poured in place and may need to be reviewed for updated VGB requirements for SOFAs.

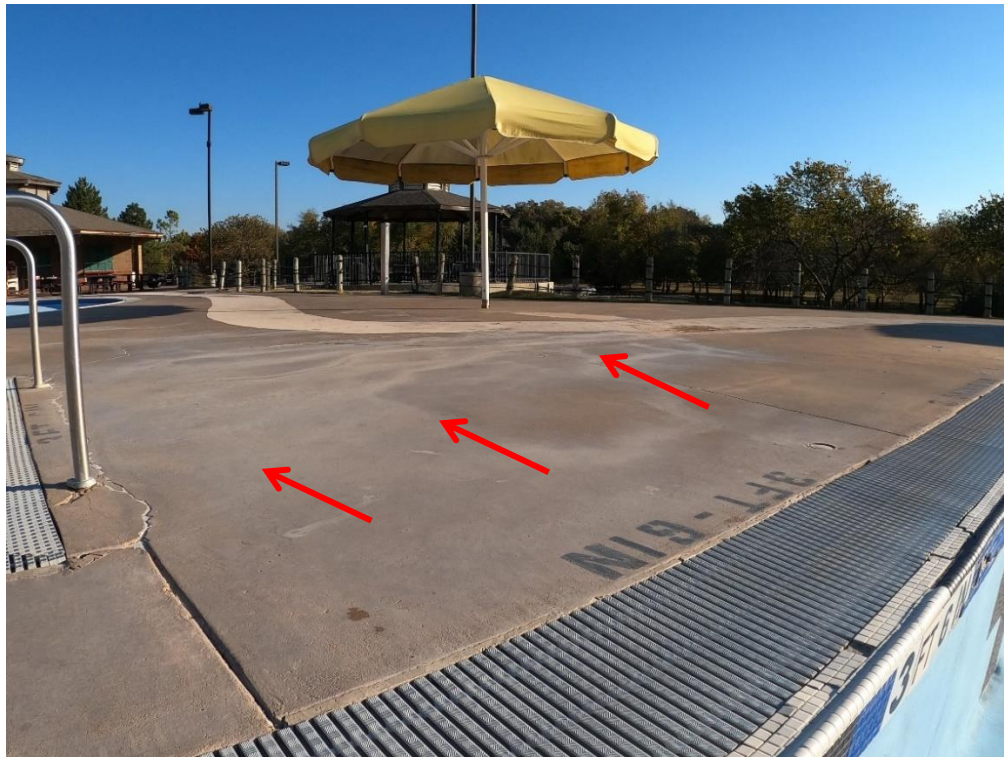
The deck north of the lap area has a low spot that appears to be stained from water ponding. The number of deck joints is insufficient to control cracking.

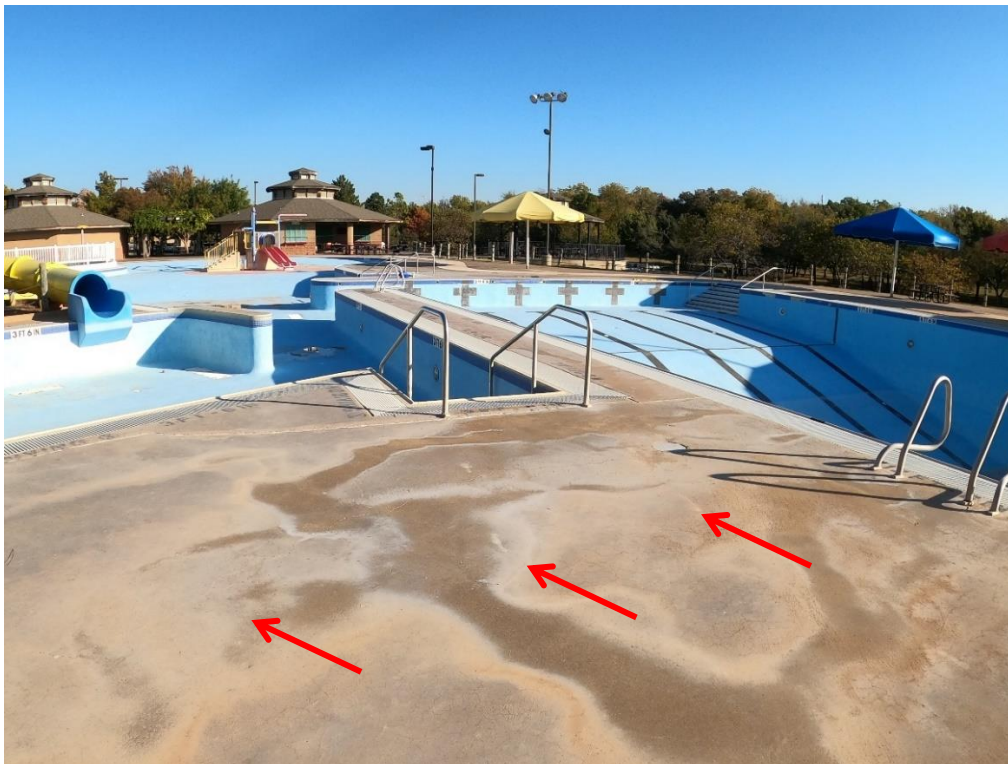
The deck south of the slide area has low spots. Water staining is apparent where water is not draining.

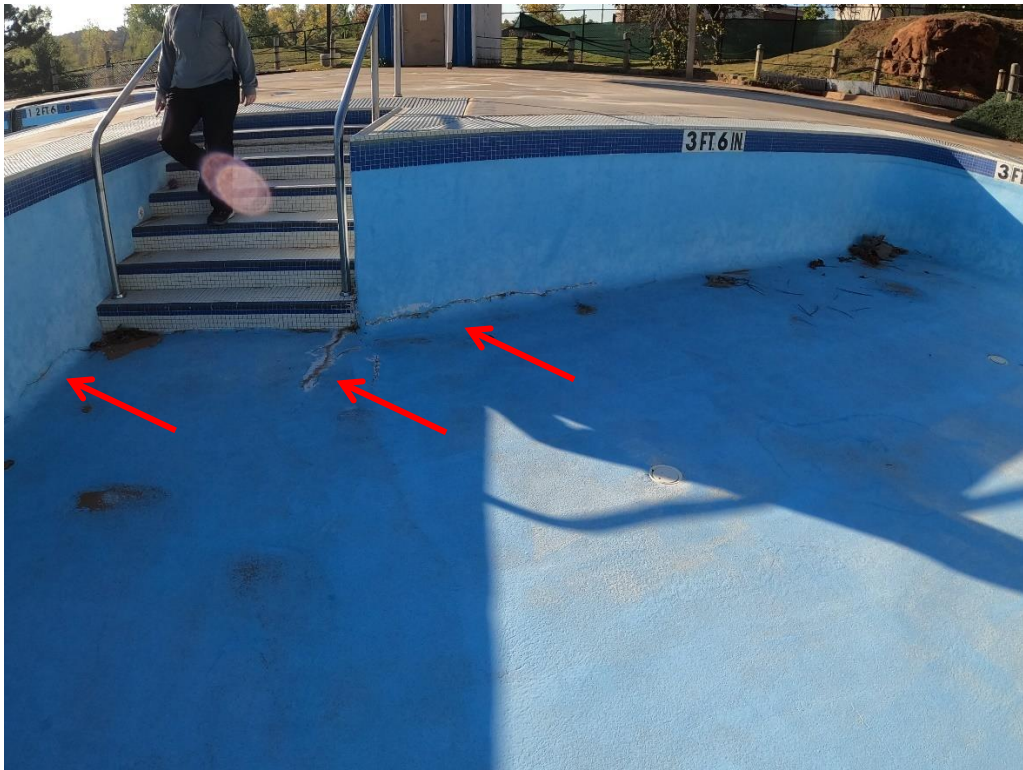
In the slide area there is movement similar to the lap area at the stairs.

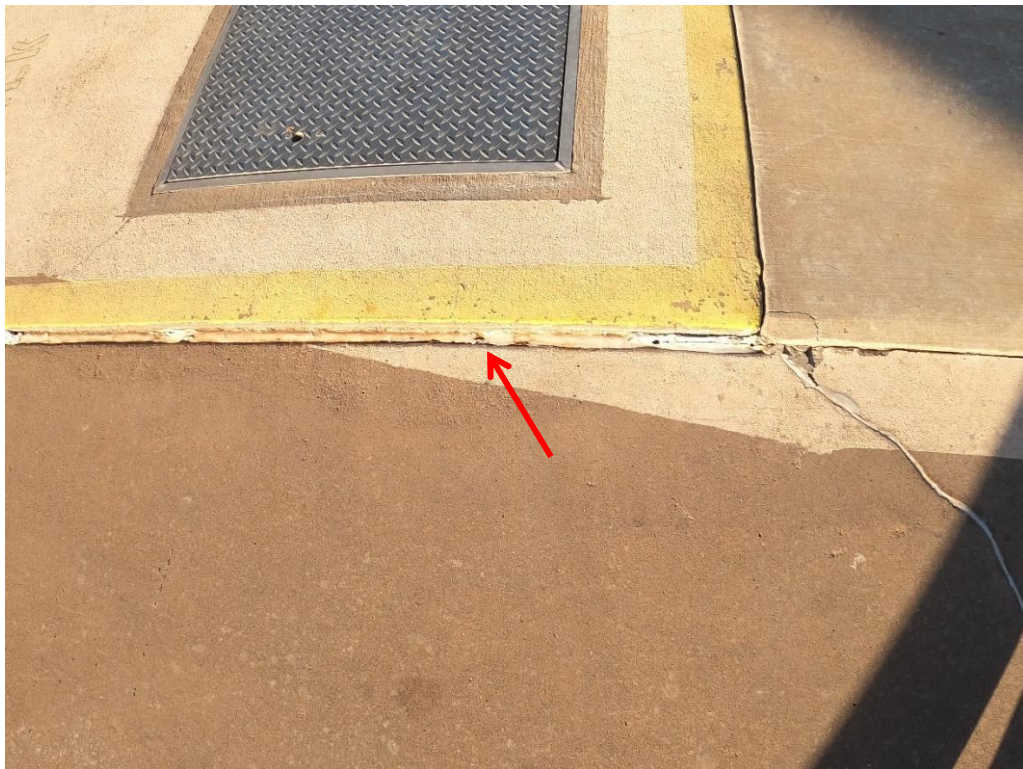
The deck around the pool surge tank has dropped and cracked.
The joint sealant has failed.

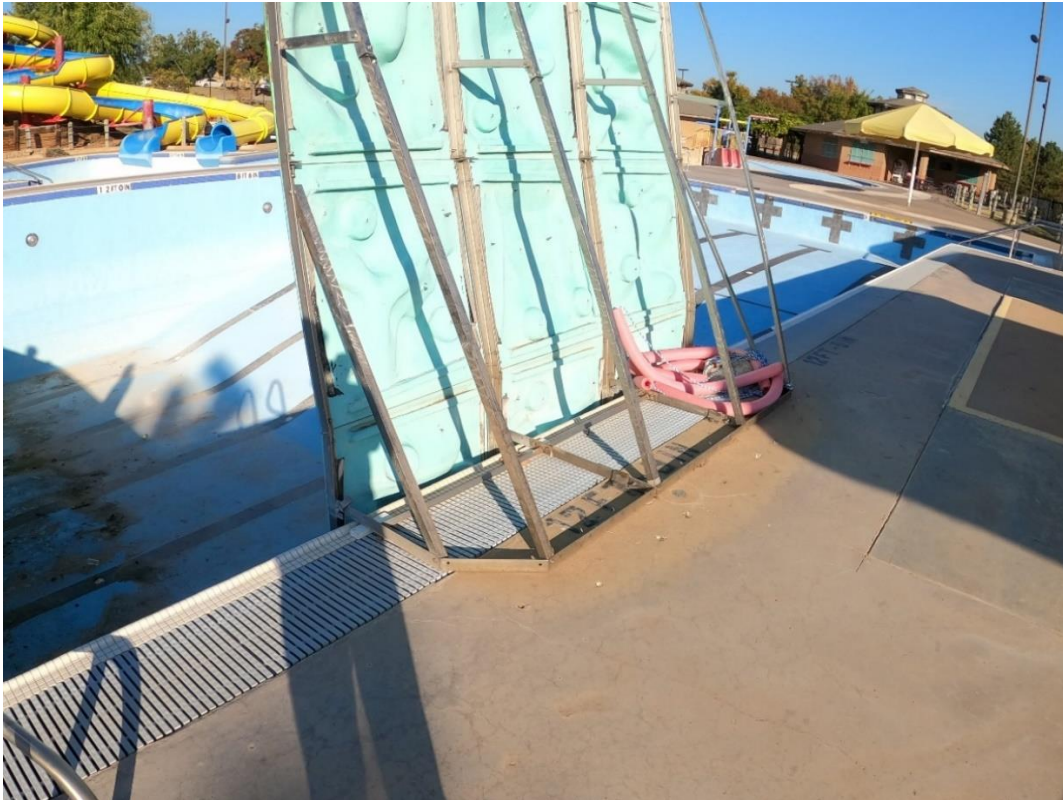
There is no bonding wire to the climbing wall and needs to be tied to the pool.

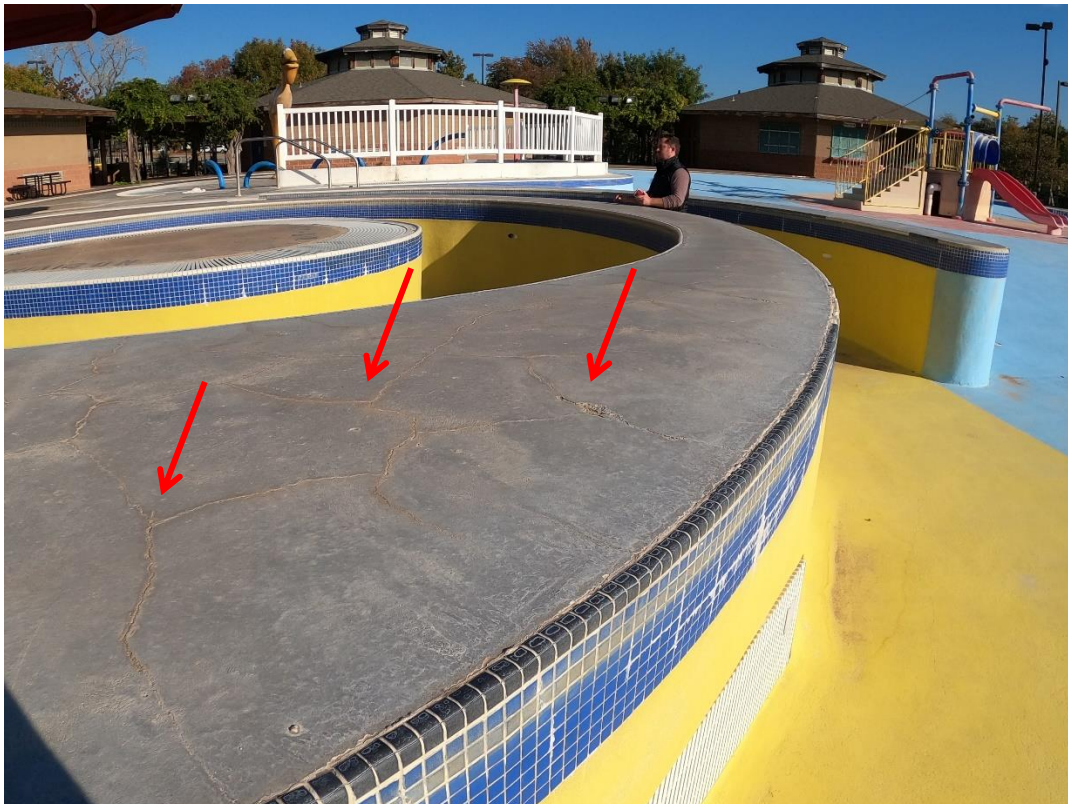
The top of the Lazy river wall has visible shrinkage cracking.

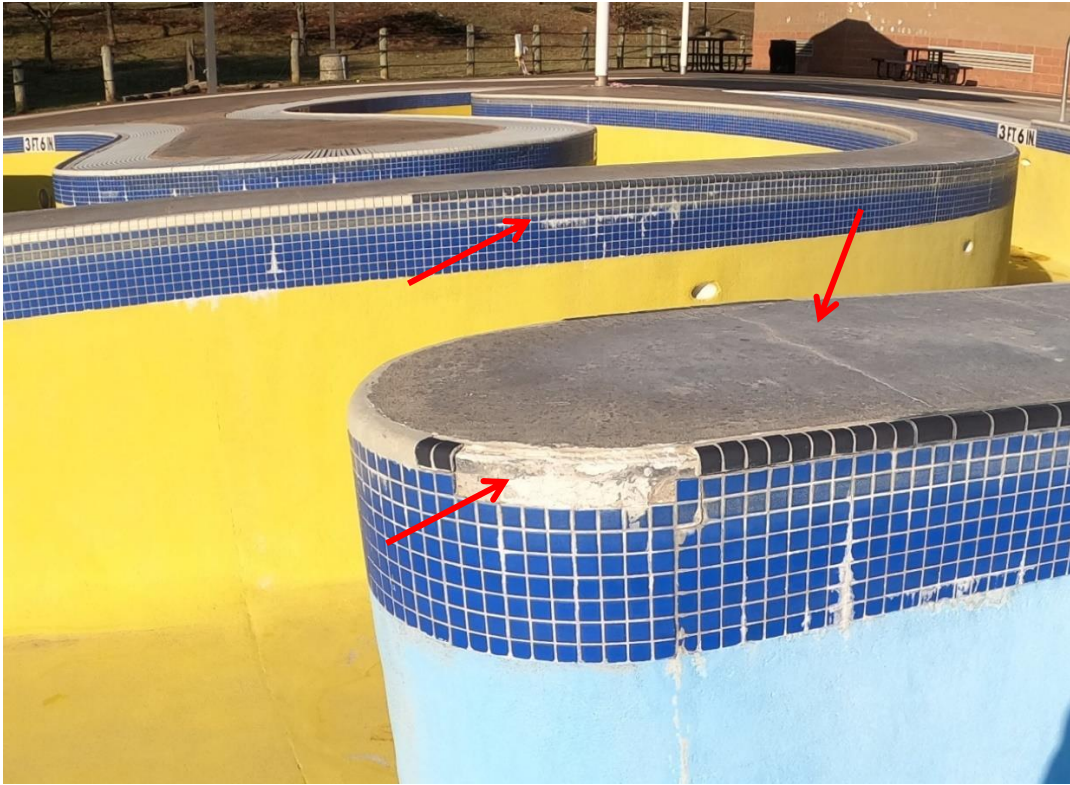
There are multiple areas of tile spalling off and cracking on top of the river wall.

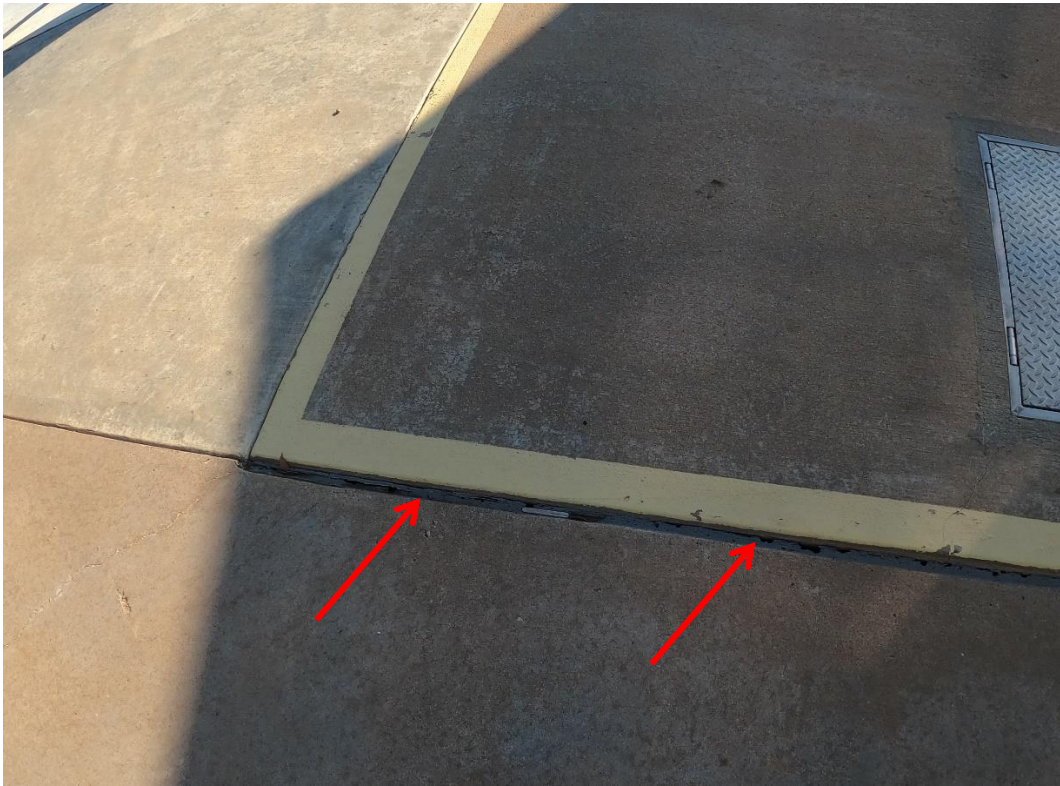
The deck around splash pad tank has moved and the joint sealant needs to be addressed.
